# Manhole Inspection Summary

Manhole # S53K\_\_015MH

Insp Date: **7/29/08 2:43 PM**

**Location** Address: **3230 fleet foster** Cross Street: **bouldin clinton**

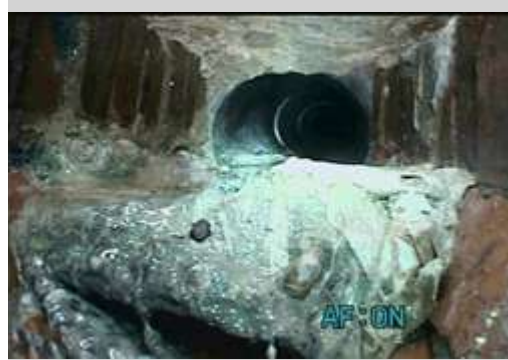
Defect 3

Condition: ☐ Sound ☐ Cracked ☐ Root Intrusion ☐ Deteriorated ☐ Leaks ☒ **Debris**

bench debris

channel debris

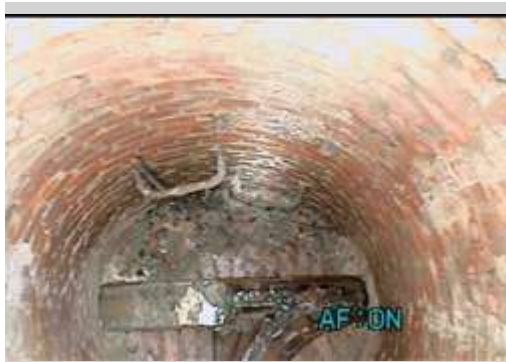
Defect 2

**Steps** Count: **4** Missing: **2** ☒ **Corroded**

steps missing, corroded

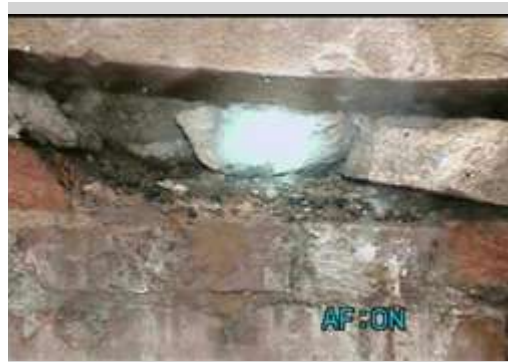
Defect 1

Condition: ☐ Sound ☒ **Cracked** ☐ Root Intrusion ☐ Loose Brick ☒ **Deteriorated**

deteriorated, cracked, frame adjustment
